WELLBORE SOLIDS AND FLUID QUALITY IMPROVED BY RENEWIQ™ SOLUTION ANNULAR CLEANUPS

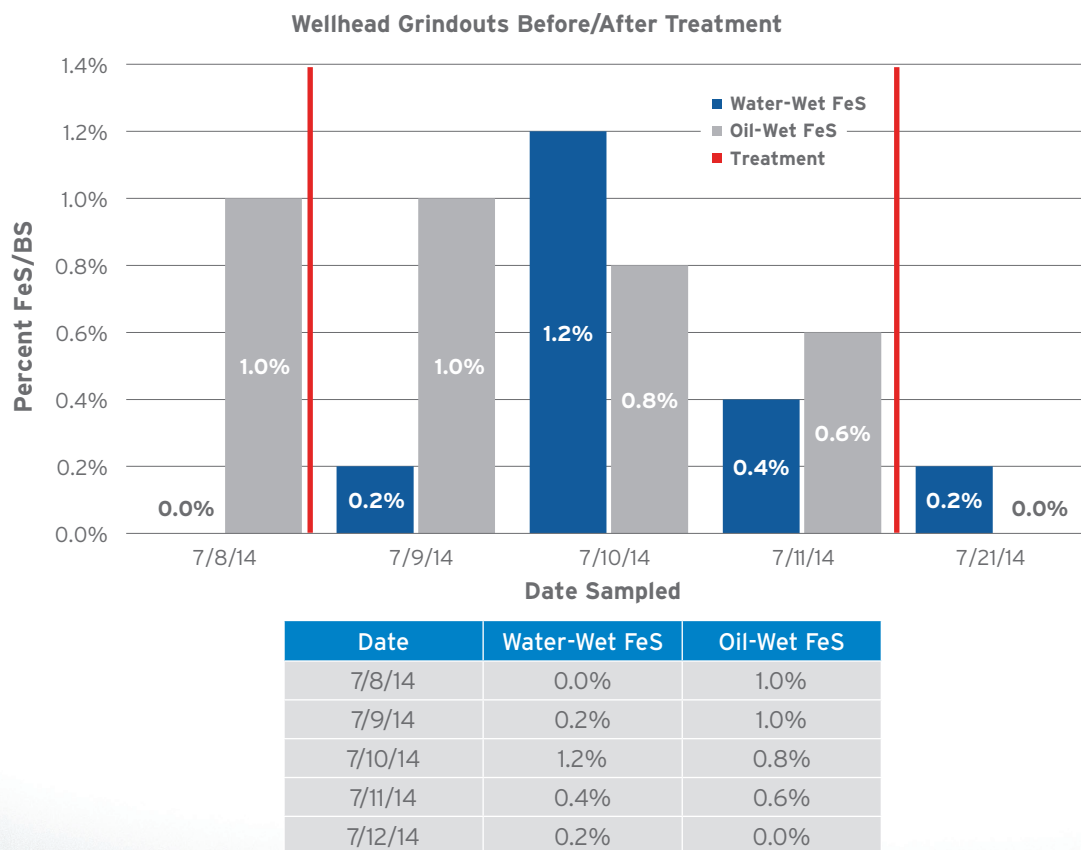
Figure 1 - Wellhead Grindouts Before/After Treatment

Baseline dynamometer scans and wellhead grindouts performed on a trial well indicated significant downhole pump issues. Grindouts indicated approximately 1.0% oil-wet iron sulfide within the production fluids, while pump and surface dynamometer cards indicated poor pump fillage along with subsequent rod stacking. The data highlighted the likely cause of the decreased pump performance to be solids-laden emulsions residing within the annular fluid column. To assist in cleaning this fluid column, consecutive annular batch treatments utilizing 1 gallon of BIOC16734A biocide and 1 gallon of FESD11088A surfactant/chelant were performed. Follow up wellhead grindouts were completed and data showed a shift from oil-wet to water-wet iron sulfide, indicating a positive effect from the treatment. Additional samples were gathered in the subsequent days, and they showed a continual reduction in the amount of oil-wet and total iron sulfide. (See Figure 1 below).

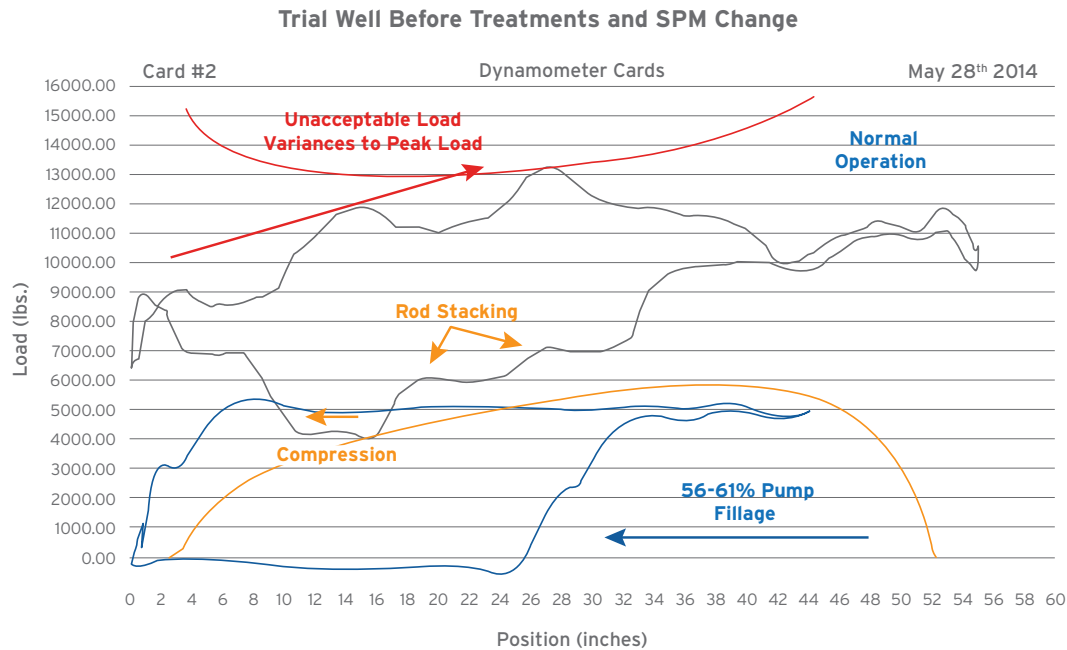
Figure 2 - Trial Well Before Treatments and SPM Change

After the second treatment, dynamometer scan results were again positive, with a noticeable improvement in both surface and pump dynamometer cards. A pump fillage of 100% was noted, improving 64% from the baseline level. (See Figures 2 and 3 below). The Nalco Champion RenewIQ solution, which focused on improving the quality of fluids

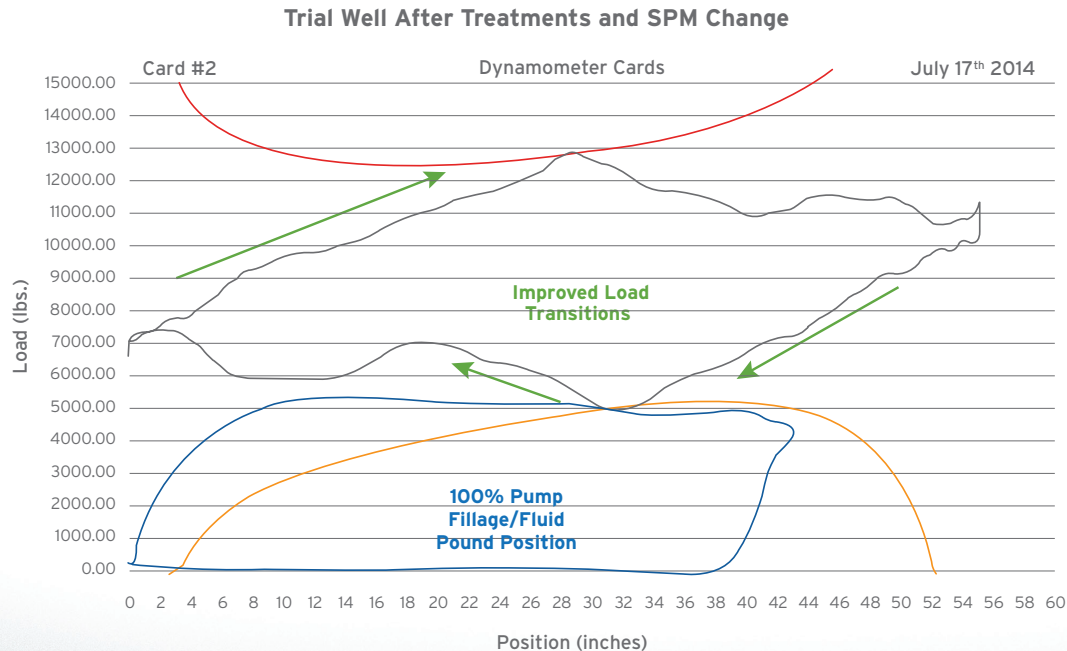
Figure 3 - Trial Well After Treatments and SPM Change
