Refinery Reduces Overhead Corrosion Through Continuous Analysis And Online Control

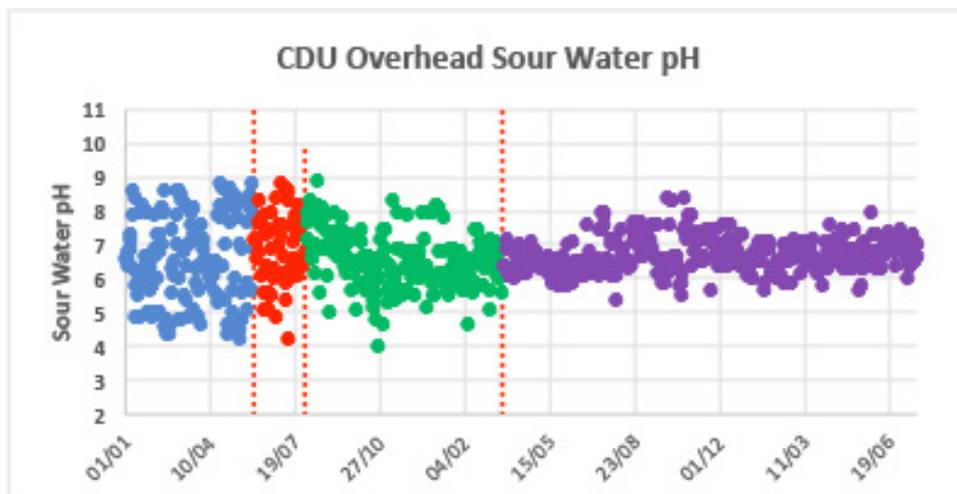
FIGURE 1: CDU OVERHEAD SOUR WATER pH

The main objective of installing the 3DTCOS analyser was to significantly improve the pH control of the overhead sour water, and consequently reduce the corrosion rates in the crude unit overhead exchangers. Figure 1 shows the daily laboratory boot water pH result before and after commissioning the 3DTCOS analyser and placing it in control mode. It is clear from this graph that since the 3DTCOS analyser was placed in control and the neutralizer dosing was automated, the variability of the overhead sour water pH significantly reduced.

| | std dev | AVERAGE | UCL | LCL |
|---|---|---|---|---|
| Pre-3DTCOS | 0.83 | 6.57 | 7.40 | 5.74 |
| 3DTCOS Monitoring Only | 1.03 | 6.92 | 7.95 | 5.88 |
| 3DTCOS Control (1) | 0.81 | 6.56 | 7.37 | 5.74 |
| 3DTCOS Control (2) | 0.51 | 6.68 | 7.19 | 6.17 |

and crude unit overhead corrosion has significantly improved, as can be seen in figures 1 and 2 on the following page.

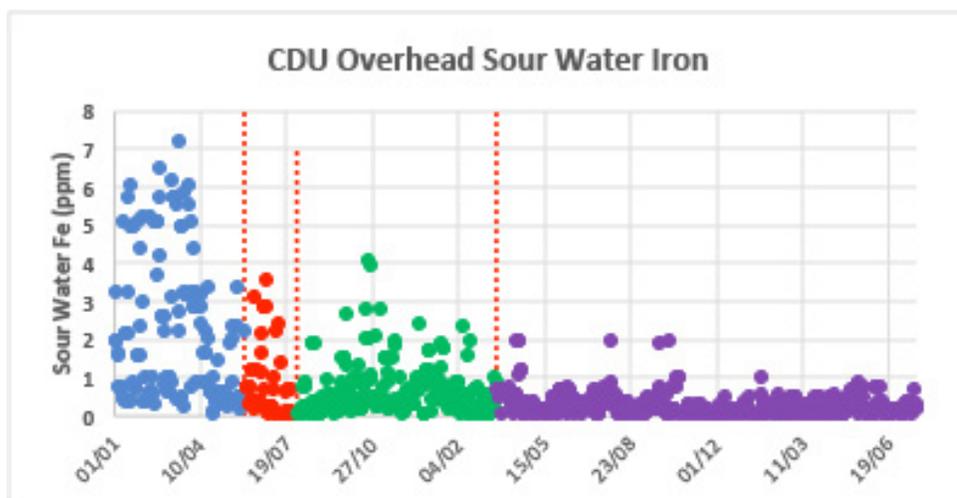
FIGURE 2: CDU OVERHEAD SOUR WATER IRON LEVELS

Figure 2 shows the daily laboratory sour water iron result over the same time period, and from this, it is clear that the control of the corrosion rates significantly improved as a result of the improved pH control.

| | std dev | AVERAGE |
|---|---|---|
| Pre-3DTCOS | 1.11 | 0.85 |
| 3DTCOS Monitoring Only | 0.90 | 0.76 |
| 3DTCOS Control (1) | 0.66 | 0.66 |
| 3DTCOS Control (2) | 0.30 | 0.30 |

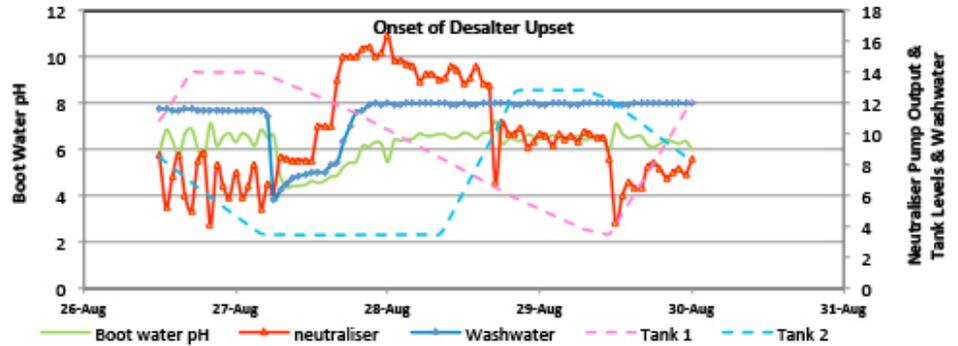
FIGURE 3: IMPACT OF WET CRUDE TANK

In one incident, the crude tank that was about to be brought online had been reported as containing a higher level of BS&W than the one currently feeding the crude unit. As this tank was brought online, desalter amps and interface levels rose sharply indicating a water slug had hit the desalter. To mitigate this event,

operators increased demulsifier dosing and reduced desalter wash water rates. Shortly after, the overhead sour water pH dropped quickly from pH 6.5 to 4.5. In response to this reduction in pH, the 3DTCOS analyser significantly increased the neutralizer dose rate.

In this scenario, the real-time monitoring immediately highlighted the low pH of the sour water and the potential for high rates of corrosion in the crude unit overheads. Without the presence of the 3DTCOS analyser, it is highly likely that this process upset would have gone undetected leading low pH conditions for a prolonged period, as any corrective action would only have taken place after the daily boot water sample was taken. This real-time analysis from the 3DTCOS analyser allowed corrective action to be initiated quickly, thus minimizing the duration of the corrosion event. Furthermore, once the unit had stabilized and the target pH was achieved, the unit optimized the neutralizer dose rate accordingly.
